2024 F-15 Worldwide Review

Overview

- F-15E Longeron Repair Initiative
- IAT 49: Front Spar Tooling Hole Cracks
- Certified Service Life Re-Certification for F-15C/D and F-15E

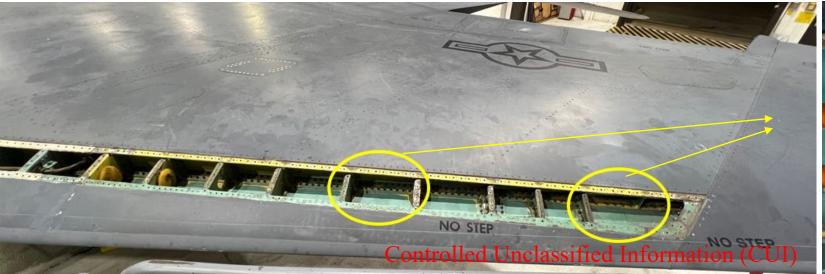
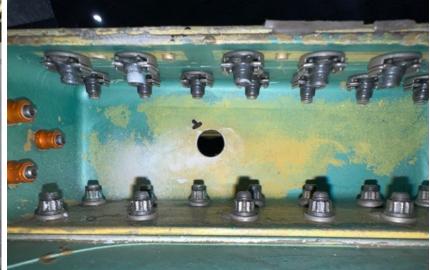
IAT 49 Front Spar Tooling Hole Cracks

- IAT 49.0 Outboard Front Spar Tooling Holes
 - 10" crack found at IAT 49.0 during unrelated field level inspection prompted installation of outboard front spar splice
 - TCTO released in Dec 2022 to inspect forward side of front spar at IAT 49.0
- Repairs Approaches:
 - Large cracks into upper/lower flanges: Outboard front spar splice installed or spar replacement
 - Smaller cracks: Temporary double L-Angle repair installed by field units with front spar splice installed at depot
- Between Dec 2022 and Oct 2024, 240 wings have been inspected
 - 45 wings had at least one crack indication
 - In the same period, configuration updates show 72% of wings already had or just received a front spar splice/new front spar
