2024 F-15 Worldwide Review

Overview

- F-15E Longeron Repair Initiative
- IAT 49: Front Spar Tooling Hole Cracks
- Certified Service Life Re-Certification for F-15C/D and F-15E

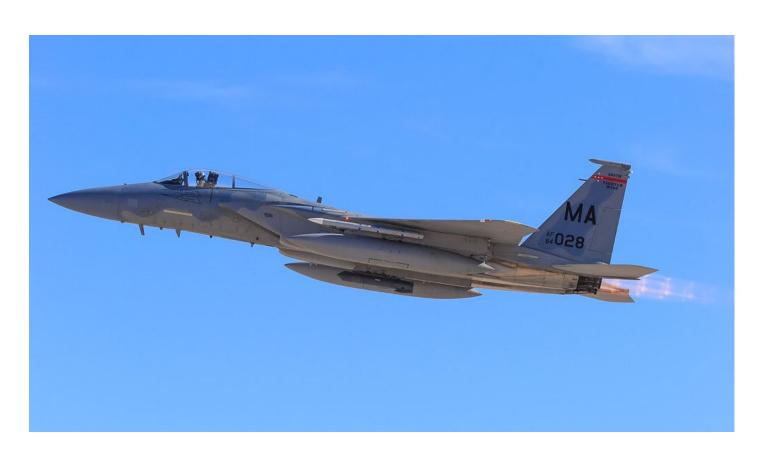
Certified Service Life for F-15C/D

- Engineering has submitted an airworthiness package to extend the service life of F-15C/D fleet to ½ of the Test Demonstrated Life (TDL), 14016.5 FTA-7 EFH
 - The timeframe for completion is no later than FY25
 - The goal is to re-certify the fleet prior to needing a new risk acceptance for continued flight
 - Known mitigating actions required for recertification
 - Canopy sill longeron, Upper aft longeron, and Upper inboard longeron must be replaced
 - All IAT inspections must continue to be done
 - Additional mitigating actions may be required

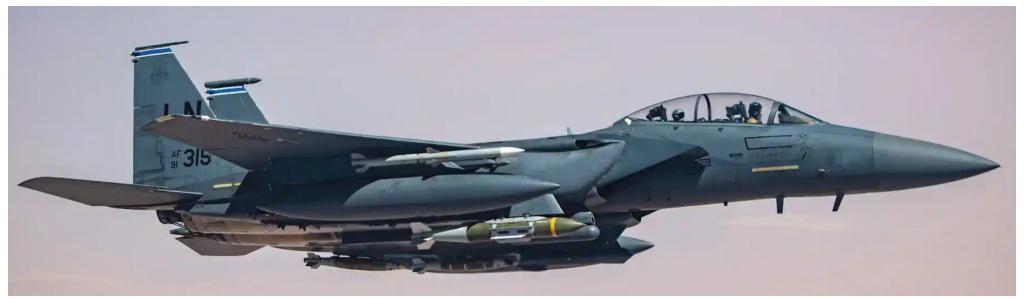
Certified Service Life for F-15E

- Engineering has recertified the USAF F-15E fleet to a new service life to 1/3 of the TDL, 16,332 FTE-10 EFH
 - Interim extension utilized a risk-based approach that incorporated USAF F-15E fleet usage, IAT inspection results, updated DTA analysis, and FTE-10 "in-test" findings as the basis for recertification
 - Mechanical components and avionics were also addressed in the recertification but did not require any mitigating actions
 - USAF F-15E aircraft required structural mitigating actions to be certified to the new 16,332 life
 - All IAT's must continue to be performed
 - All holes in IAT 69 must be coldworked IAW 1F-15-1679

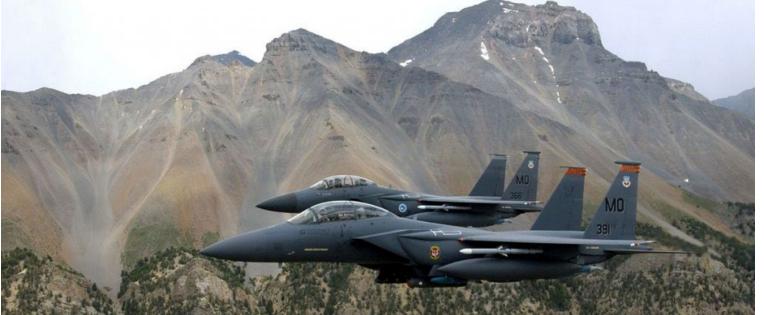
Certified Service Life for F-15E

- Recertification to 1/2 TDL, 24,498 FTE-10 EFH is in work but may be several years before completed
- FTE-10 Teardown has been completed by S&K and all findings have been sent to Boeing
 - Boeing is using these findings to create or update DTA's
 - USAF will then use these new DTA's to form updated inspection criteria and/or PDM tasks
- Recertification to 24,498 may have additional mitigating requirements that must be complied with to take advantage of the new certified life
 - These mitigating actions are unknown at this time and will be established during the recertification process
